Mariusz Ziejewski, Ph.D., Inż.

June 20, 2018

RE: Ms. K [REDACTED] M [REDACTED] F [REDACTED]

Pursuant to your request, I am setting forth my biomechanical opinions regarding the motor vehicle accident on March 17, 2014, involving K [REDACTED] F [REDACTED]. I am also providing a summary of my background and qualifications to render my opinions.

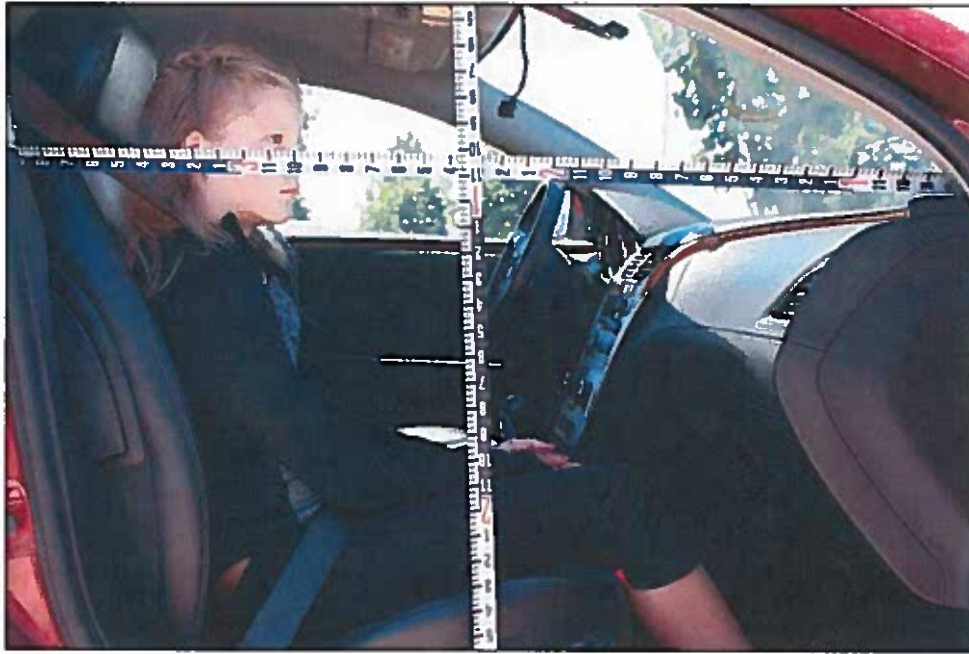
Figure 16 – Surrogate Fit in Exemplar Chevrolet Malibu

The objective of the surrogate fit (Figure 16) was to relate geometrical dimensions of the 2012 Chevrolet Malibu to the height of Ms. Faust's 58 inches. The GEBOD (AL/WPAFB) computer program was used to generate the body description for Ms. Faust's anthropometry. The GEBOD output indicates the seated height of 30.55 inches. The selected surrogate GEBOD output had a seated height of 30.2 inches resulting in a 0.35 inch lesser seated height for the surrogate as Ms. K█████ F█████. Additionally, GEBOD output data set includes the body segments' geometric and mass properties and the joints' locations and range of motion characteristics that allows for detailed dimensional comparisons. Only a surrogate having similar underlying skeletal dimensions in comparison to Ms. Faust is of relevance in static geometrical fit. Primarily, surrogate height is used for analysis.

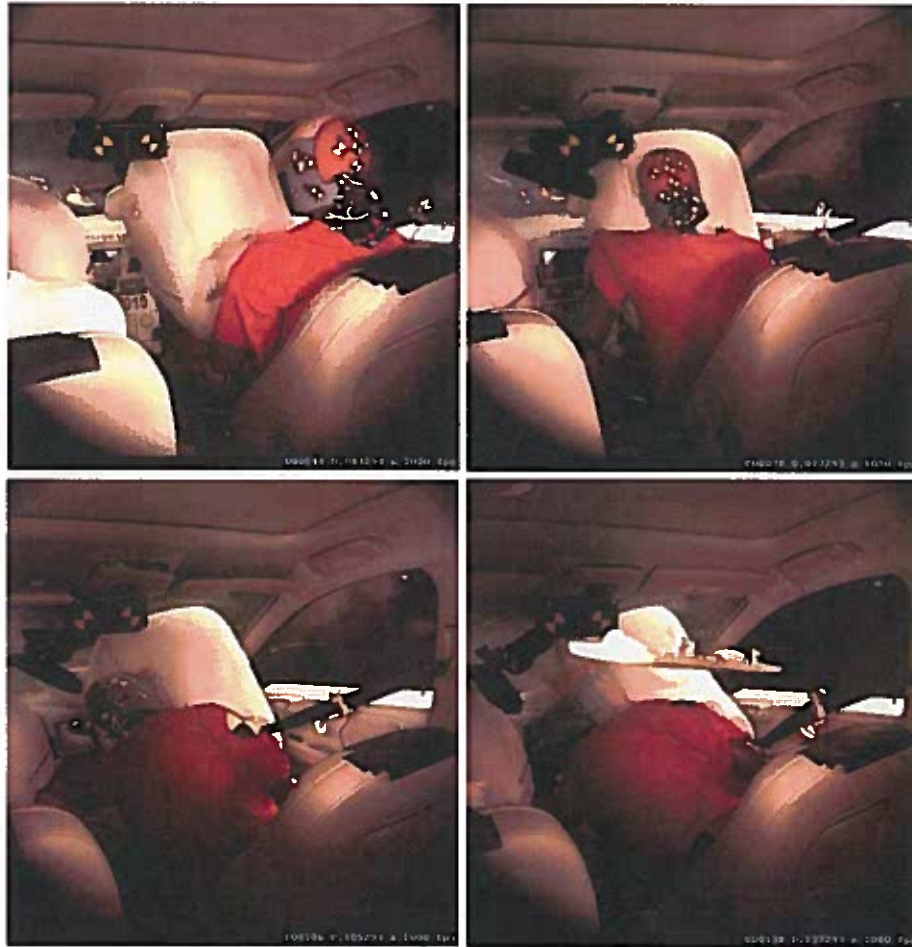
Figure 19 – Shoulder Belt Slip Out for Right Front Passenger, NHTSA Test No. RD5910

An example illustrating shoulder belt slip-out for conditions substantially similar to the subject event is NHTSA Test No. RD5910. As shown in Figure 19, the test was a frontal oblique offset collision at 90.1 kph (approx. 56 mph), PDOF of -15° (to the left) and 35% overlap (2013). Unlike the subject incident, the test conducted by NHTSA shows front right passenger airbag deployment and no excessive intrusion to the driver's side compartment.
